# KINGSLEY COVERED BRIDGE

CLARENDON BO 1443(55)  
TH 39, BRIDGE NO. 28 OVER MILL RIVER

HCBPC PRESENTATION

OCTOBER 14, 2020

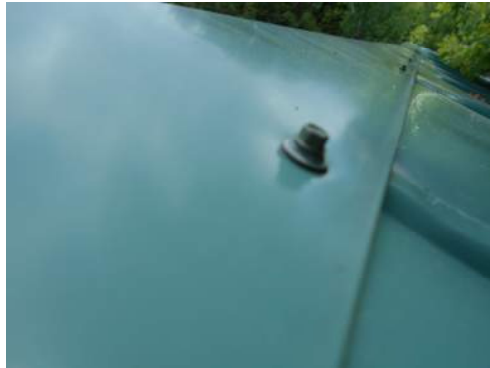
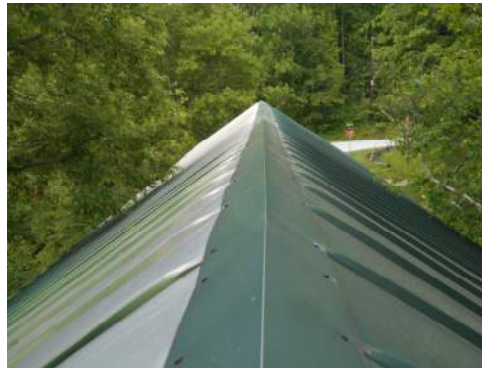
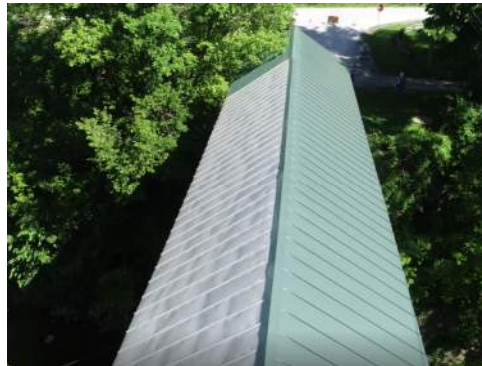
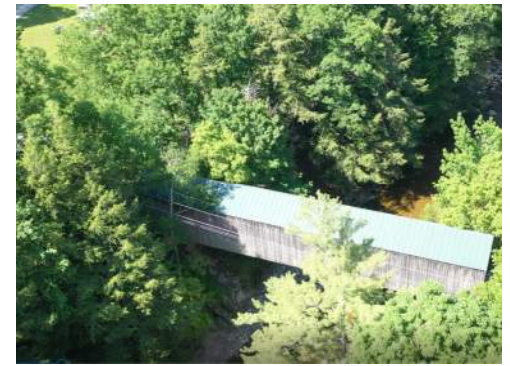
# INSPECTION FINDINGS: METAL ROOF

Paint Blistering,  
Fading, Ridge  
Cap Attached  
with Nails &  
Screws, Trees  
Overgrown

- New Standing Seam Metal Roof
- Rafters are 3”x5” or 4”x5” Eastern Spruce
- Roof Boards are 1” thick Eastern Hemlock
- 20% Replacement of Existing Roof Boards (PTN 2)
- 12 Rafters (19%) to be Replaced due to Condition (PTN 2)
- 5 Rafters to be Epoxy Repaired (PTN 3)

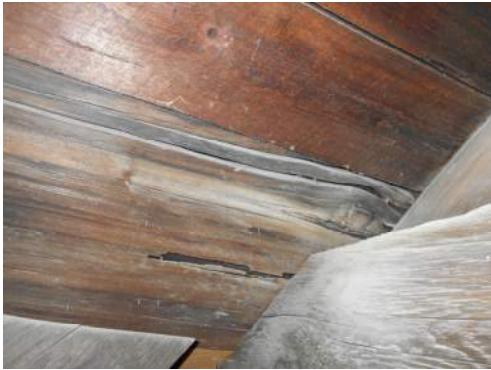
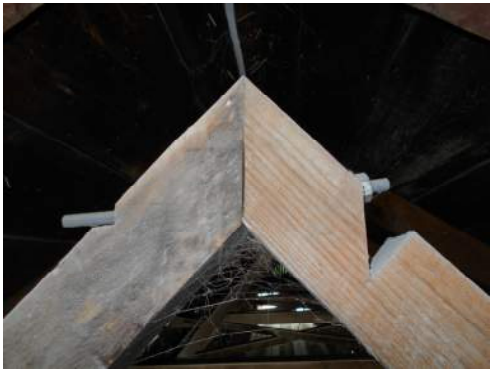
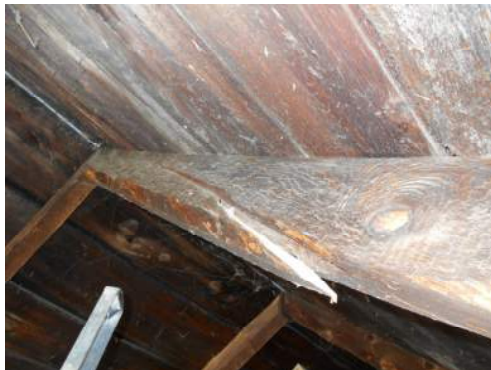
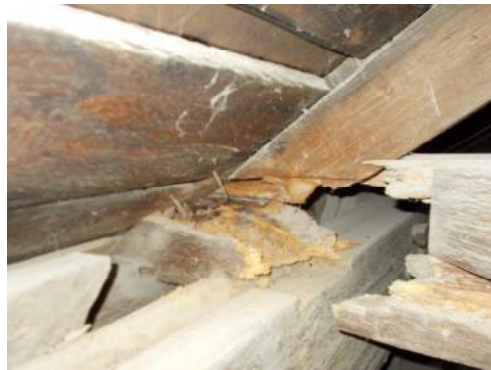
# INSPECTION FINDINGS: ROOF MEMBERS

Splits, Breaks,  
Rot,  
Overcuts,  
Insect  
Damage

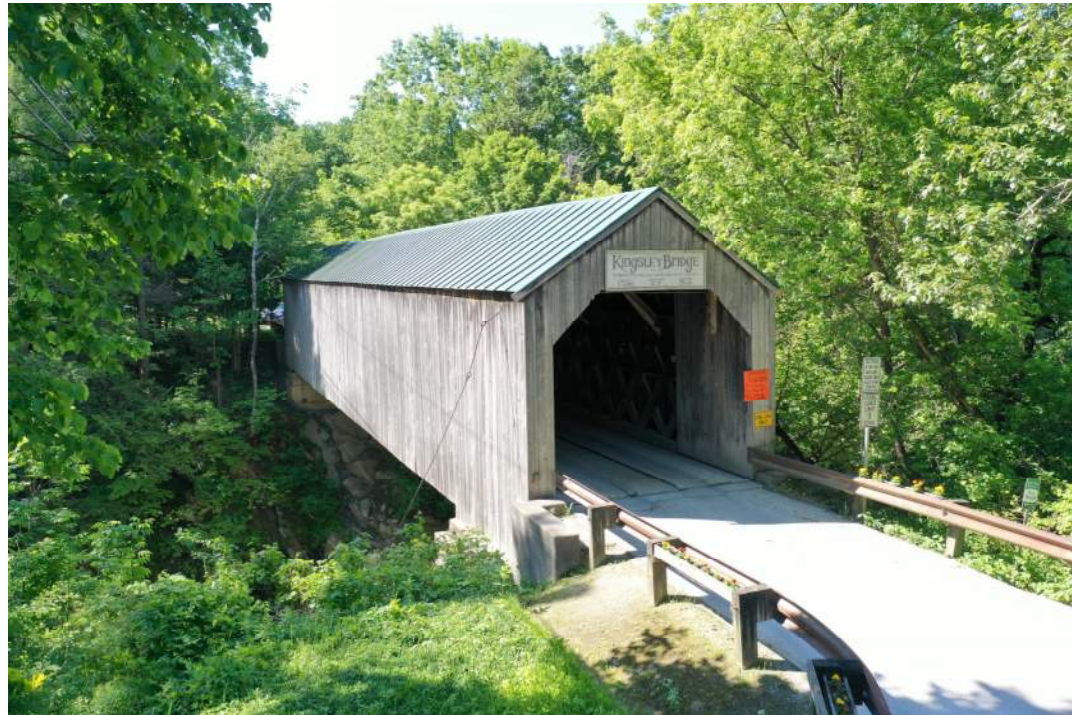
# INSPECTION FINDINGS: BRACING MEMBERS

Guy wires  
not well  
anchored

- Existing Lateral Bracing not Adequate to allow removal of guy wiring.
- Strengthen Crossbeam to Chord connection or
- Add Additional Lateral Bracing Below the Crossbeam

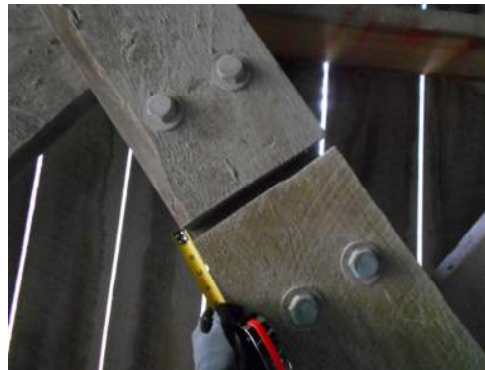
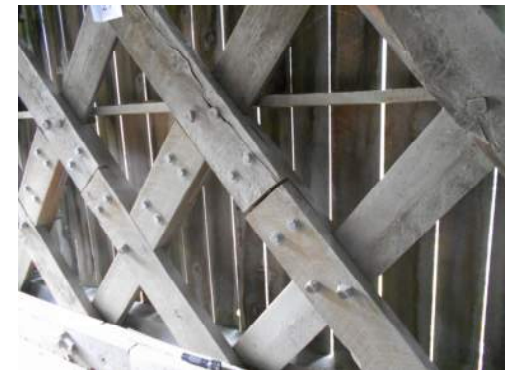
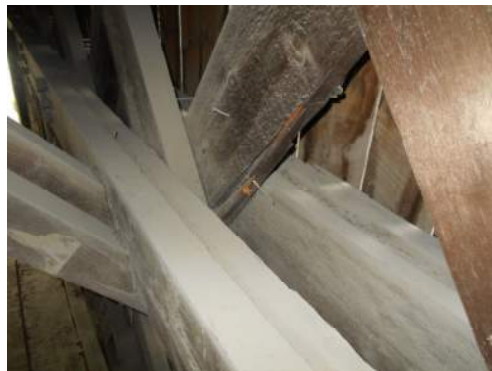
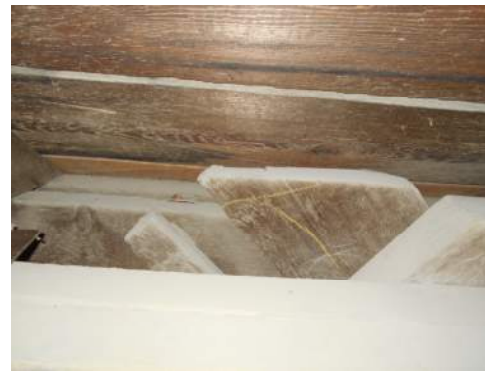
# INSPECTION FINDINGS: LATTICE MEMBERS

Large Gaps at  
Previous  
Splices, Splits,  
Breaks, Rot,  
Insect  
Damage

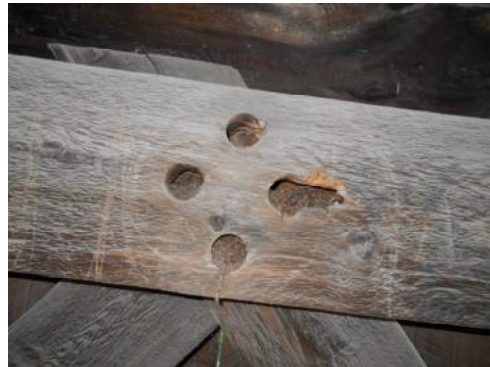
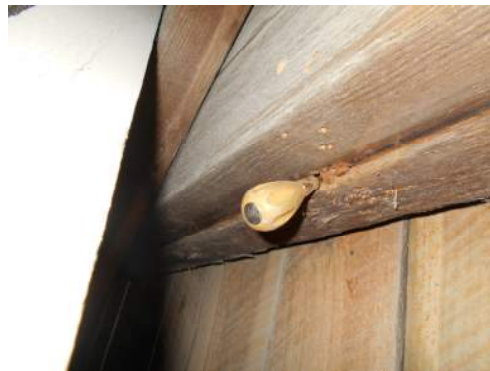
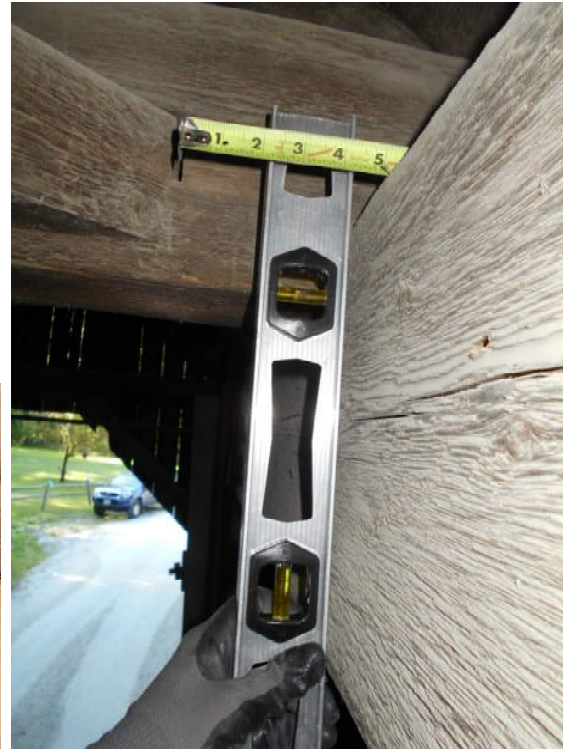
# INSPECTION FINDINGS: TOP CHORD MEMBERS

Out of Plumb,  
Splits, Breaks,  
Rot, Insect  
Damage

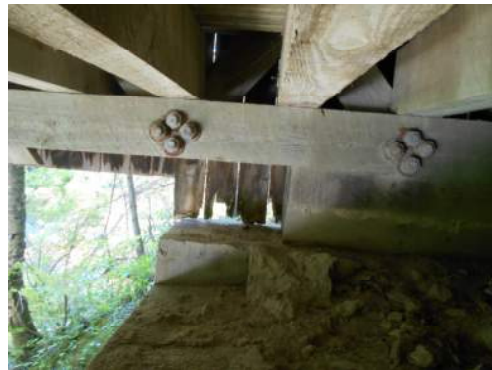
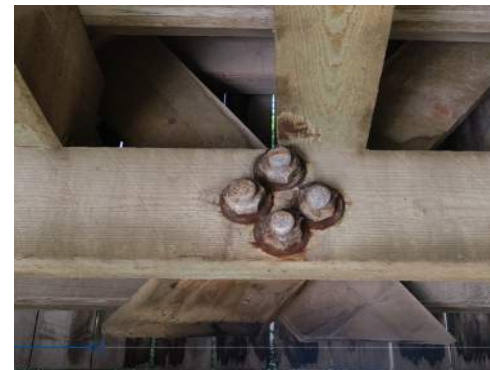
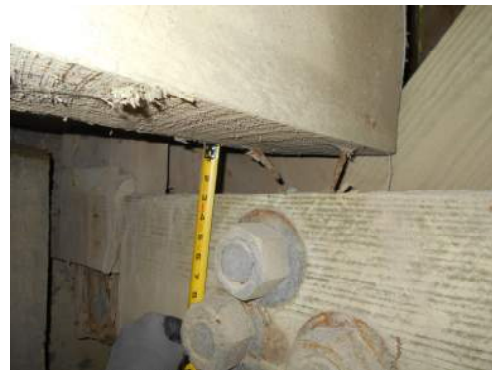
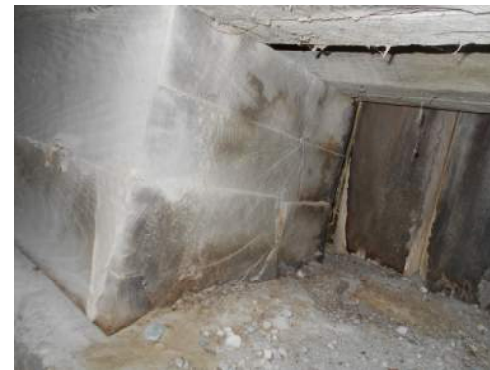
# INSPECTION FINDINGS: BOTTOM CHORD MEMBERS

Bedding  
Timbers  
Rotted,  
Settling of  
Trusses,  
Rusting of  
Bolts

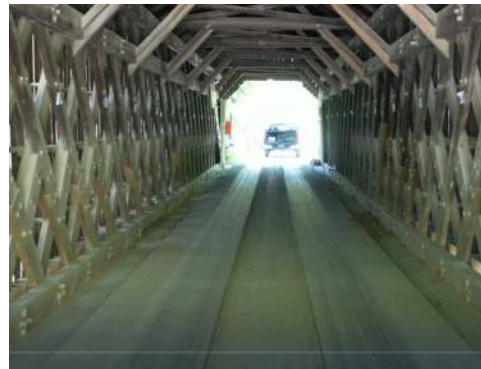
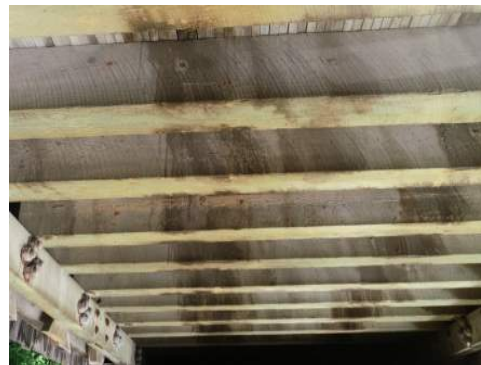
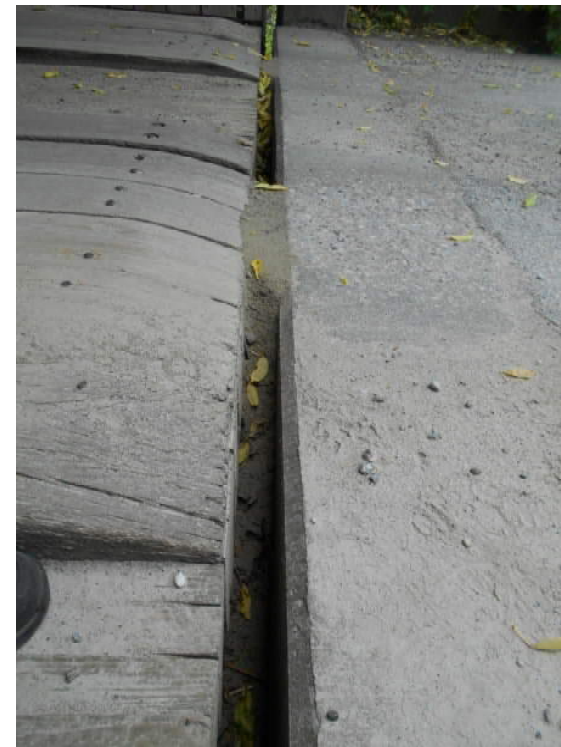
# INSPECTION FINDINGS: FLOOR MEMBERS

Runners Trap  
Debris,  
Ramps Each  
End

- Floor Members Include 8”x14” Floorbeams, 2”x6” Nail Laminated Deck and 3” thick Runner Boards
- Floorbeams are Southern Pine and Decking is Eastern Spruce
- Nail Laminated Deck Adequate for H20
- Floorbeams Adequate for H15
- Replace Runner Boards with full width Runners (PT 2)
- No Floorbeam/Deck Replacement or Repair Required

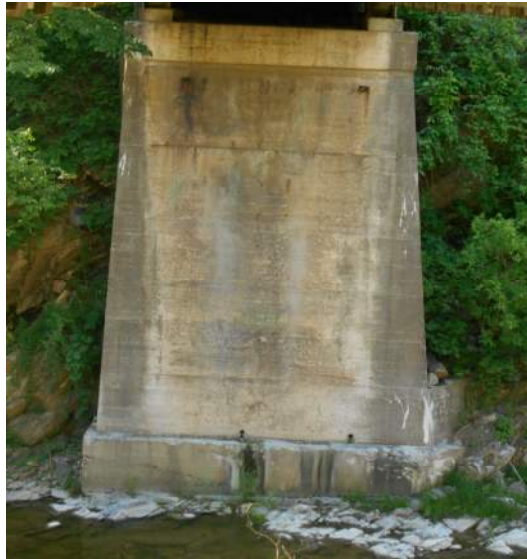
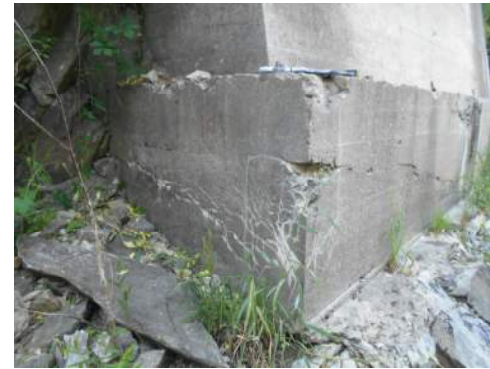
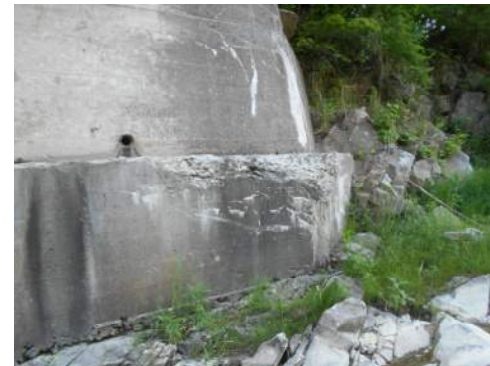
# INSPECTION FINDINGS: SUBSTRUCTURE

Concrete  
Cracks,  
Spalling,  
Delamination,  
Efflorescence  
Staining

- Concrete Repair / Crack Sealing (PT I)
- Stain And Seal Concrete (PT I)
