THE BRIDGER

The Vermont Covered Bridge Society Newsletter – Issue #89

THEY ARE REHABILITATING MY FAVORITE COVERED BRIDGE

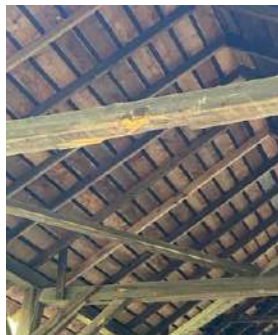
The Red Bridge in Sterling-Morristown was damaged in 2021, when an oversized box truck pushed its way through and damaged the tie beams. Two beams look just scraped, while one has damage on both sides.

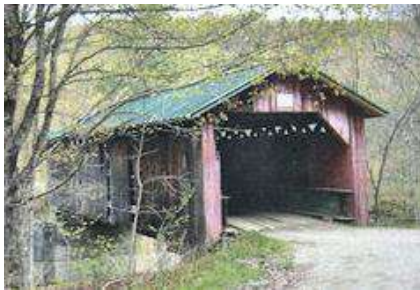
The Hutchins Covered Bridge was inspected and load rated to determine its current condition. Our rating assumes replacement of deteriorated bridge members. It was determined that at the inventory stress limit, the existing trusses have a live load capacity of approximately H7.8 (7.8 tons), the floor beams have a capacity of H4.2 (4.2 tons), and the deck has a capacity of H7.2 (7.2 tons).

The Hutchins Covered Bridge is located in the town of Montgomery, Vermont, and was built in about 1883 by Sheldon and Savannah Hewett of Montgomery. The bridge's 76-foot single span timber superstructure utilizes Town lattice trusses, spaced at 17'-10" on-center. The bridge runs east to west and crosses over the south branch of the Trout River on Town Highway No. 27. It is supported by abutments originally constructed out of large stones. The east abutment has been encased with concrete. The west abutment is constructed from dry laid stones and abuts the former Hutchins Mill foundation, which serves as the northwest wing wall. The bridge is open to traffic and is on the National Register of Historic Places.

The Hutchins Covered Bridge was inspected and load rated to determine its current condition. Our rating assumes replacement of deteriorated bridge members. It was determined that at the inventory stress limit, the existing trusses have a live load capacity of approximately H7.8 (7.8 tons), the floor beams have a capacity of H4.2 (4.2 tons), and the deck has a capacity of H7.2 (7.2 tons).

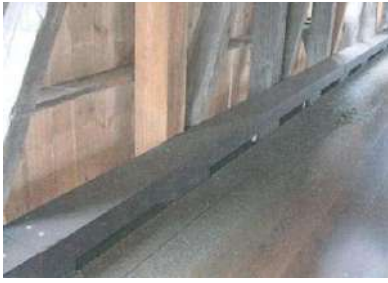
The existing floor beams and decking were analyzed to determine their live load capacity. The deck capacity was determined to be H7.2 (7.2 tons), assuming a No. 1 grade. The floor beam capacity was determined to be H4.2 (4.2 tons) for a No.1 grade at inventory and H5.9 (5.9 tons) at operating.

Based on the condition of the deck and floor beams and an H6.0 (6.0 tons) live load goal, we recommend complete replacement of the floor beams and decking with new sawn members of approximately the same size. The species of the new members would be Douglas Fir or Southern Pine to meet the H6.0 (6.0 tons) live load requirement. If H20.0 (20.0 tons) live load capacity is required, glulam decking and floor beams would be required as discussed above. In addition, we recommend that a new wood curb be added to the bridge to help keep vehicles from impacting the trusses and knee braces. This curb has previously been used by VTrans on the Union Covered Bridge in Thetford, the Comstock Covered Bridge in Montgomery, and the Greenbanks Hollow Covered Bridge in Danville.
